Monitoring Data Record

Project Title: R-2248BB – Charlotte Outer Loop COE Action ID: 200131321
 Stream Name: UT Thomas Pond (Site 9) DWQ Number: 011231
 City, County and other Location Information: Mecklenburg County, Charlotte Outer Loop, NC 27 Exit (Mount Holly Road)
 Date Construction Completed: April 2005 Monitoring Year: (1) of 5
 Ecoregion: _____ 8 digit HUC unit 03050101
 USGS Quad Name and Coordinates: _____

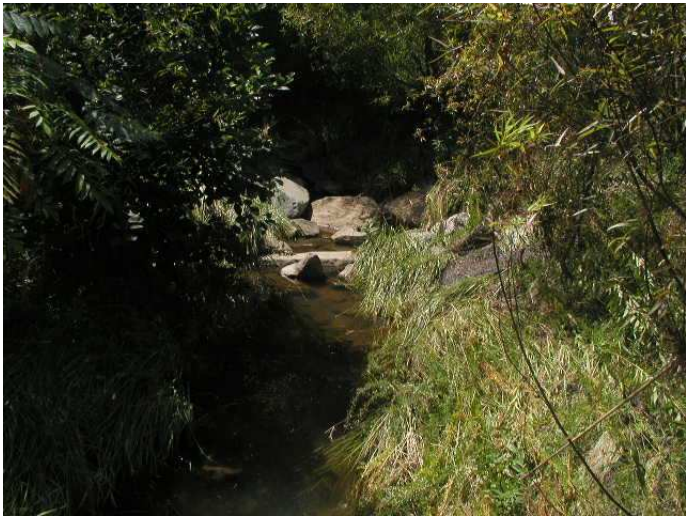
UT Thomas Pond stream relocation is stable for the Year 1 Summer evaluation. The crossvane at Photo Point #1 (Upstream) has water piping under crossvane but the stream is stable at this time. There was also some minor bank scouring at the outlet end of the box culvert at Sta 219+80 -L- on the left and right bank (additional photo showing this area) noted last monitoring evaluation. This area has begun to stabilize with some herbaceous and woody vegetation. There is evidence that a bankfull event has occurred since the last monitoring evaluation. NCDOT will continue to monitor this stream relocation for channel stability.

Date 9/3/08	Station 17+40 Y-10	Station Number	Station Number	Station Number	Station Number
Structure Type	Crossvane @ inlet of pipe				
Is water piping through or around structure?	Water is piping under crossvane.				
Head cut or down cut present?					
Bank or scour erosion present?					
Other problems noted?

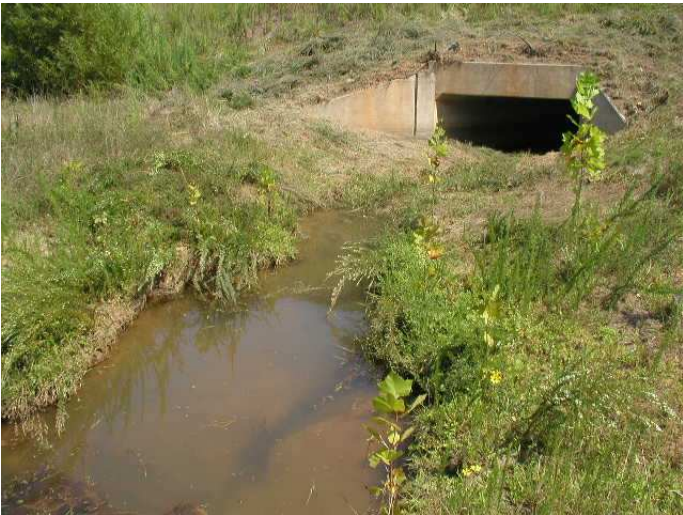
Bank Scouring @ Sta. 219+80-L- noted last evaluation that has begun to stabilize with herbaceous and woody vegetation
